Third Five-Year Review Report for Iron Mountain Mine Superfund Site Redding, California

September 2003

Prepared By:
United States Protection Agency
Region 9
San Francisco, CA

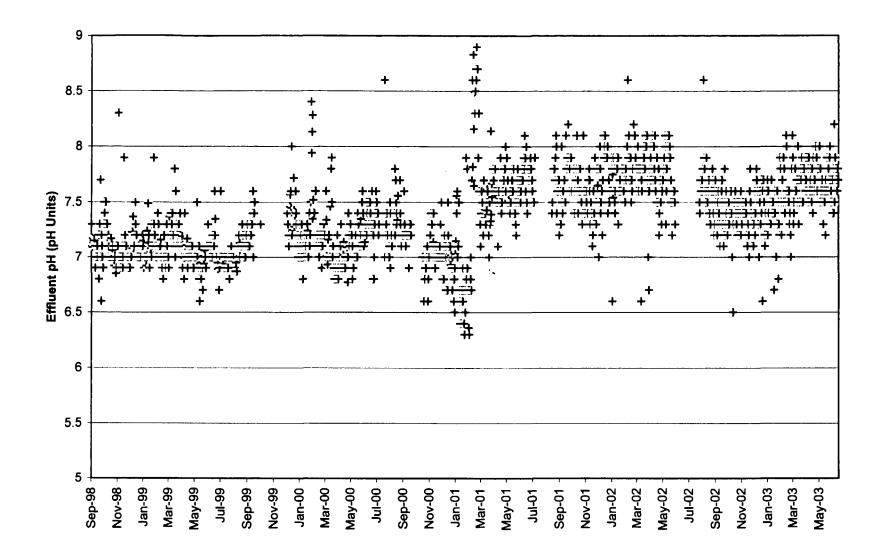
FIGURE 3
MTFP EFFLUENT- DAILY pH
IRON MOUNTAIN MINE 5-YEAR REVIEW

Figure 3 provides a plot of MFTP effluent pH from the period October 1998 through July 2003. No exceedences of the daily or monthly CWA limits for pH were observed for the MFTP plant effluent during the period.

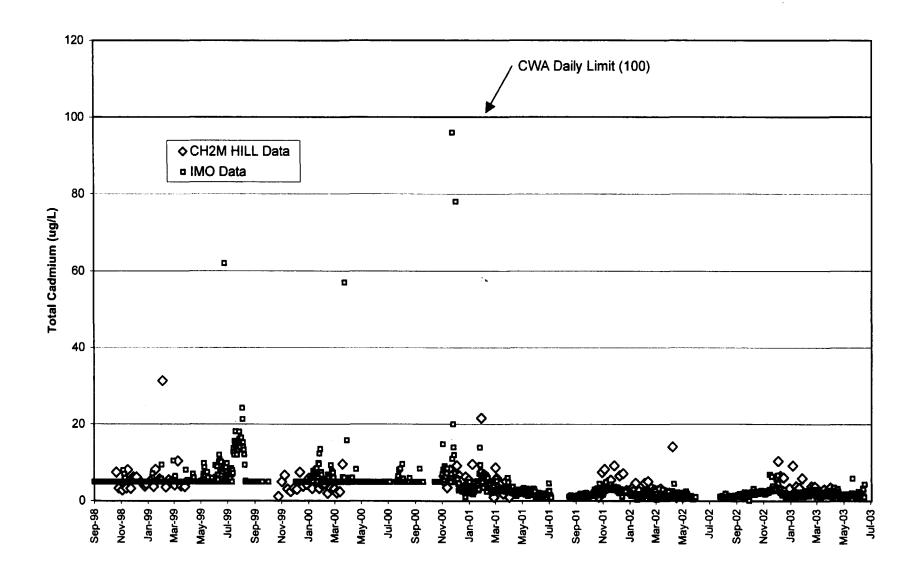
FIGURE 4
MFTP EFFLUENT
DAILY TOTAL CADMIUM
IRON MOUNTAIN MINE 5-YEAR REVIEW

Conclusion: The treatment plant is in substantial compliance with the CWA effluent limitations for total cadmium, total copper, total zinc, and total lead. The instances where daily or monthly exceedences occurred were rare and can likely be attributed to operational conditions or other known factors.

Recommendation: No change in the CWA effluent limitations is recommended.

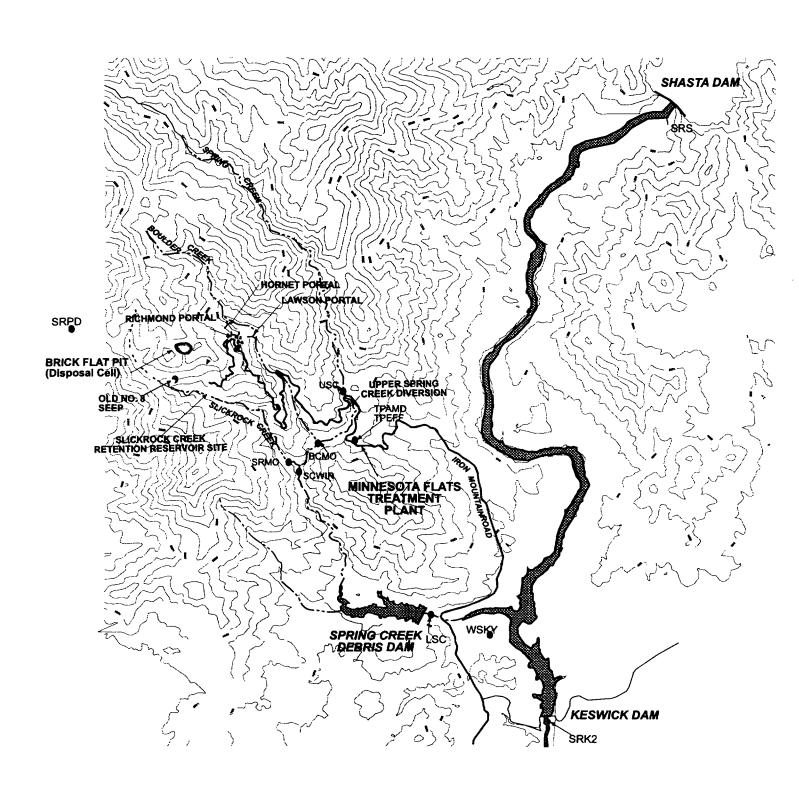
FIGURE 1 LOCATION MAP IRON MOUNTAIN MINE FIVE YEAR REVIEW

Iron Mountain is located approximately 9 miles northwest of Redding, California. The mountain is bordered to the south/southwest by Slickrock Creek and to the north/northwest by Boulder Creek, as shown on Figure 1. Acid mine drainage (AMD) from abandoned mine workings, waste piles, and other area sources discharges and contaminates Boulder and Slickrock creeks. These creeks flow into Spring Creek, which subsequently flows into Spring Creek Reservoir, Keswick Reservoir, and the Sacramento River.

Contaminants from Boulder and Slickrock creeks discharge through SCDD into Keswick Reservoir, as depicted in Figure 1. As reported in the previous five-year review memorandum (Site Evaluation, Iron Mountain Mine, September 25, 1998), the State of California Regional Water Quality Control Board, EPA, and the USBR have routinely collected samples at SCDD to monitor pH, total copper, total zinc, and total cadmium in the reservoir discharge.

During the five-year review period, the USBR conducted routine sampling of SCDD (LSC), Shasta Dam (SRS) and Keswick Dam discharges (SRK2). Sampling and testing was conducted weekly during normal operations and more frequently during changes in releases, storm events, or overtopping of SCDD. The purpose of the sampling was to assist the USBR in regulating discharges from SCDD to meet water quality objectives for the Sacramento River downstream of Keswick Dam. The sampling locations are shown on Figure 1.

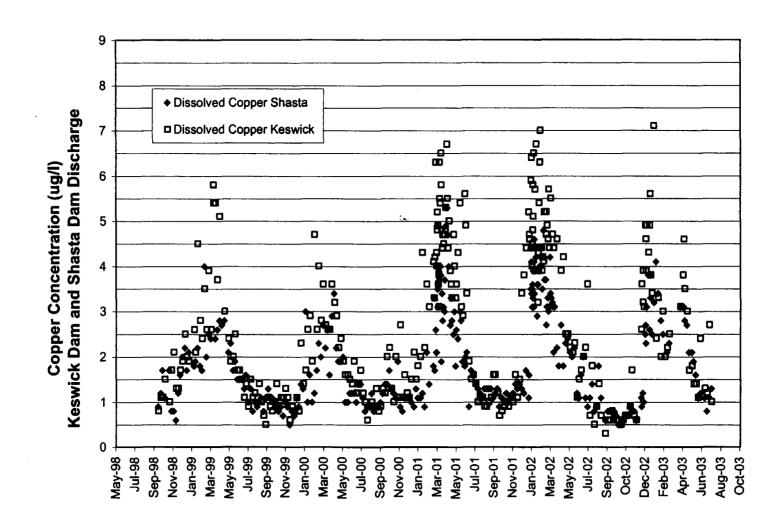
FIGURE 6
DISSOLVED COPPER CONCENTRATION
SHASTA DAM AND KESWICK DAM DISCHARGE
IRON MOUNTAIN MINE FIVE-YEAR REVIEW

The ratio of the concentrations provides a very approximate indicator of the relative copper load contributions from Shasta Dam to the Keswick Dam discharges. A more comprehensive sampling program and mass balance analysis would be required to more accurately evaluate the actual load contributions. The mass balance analysis would need to evaluate travel time from Shasta Dam to Keswick Dam, dilution from Whiskeytown Reservoir through the Spring Creek Powerhouse, accretion flows, precipitation, and load contribution from SCDD.
